A PRESENTATION OF LOW-TROP ARCHITECTURE OF YOLA

*A presentation submitted to the Department of
Architecture. In the partial fulfillment to the
requirement of AR403; Theory of Architecture*

MARCH 2006

Low Trop Buildings in Yola, Adamawa State Capital

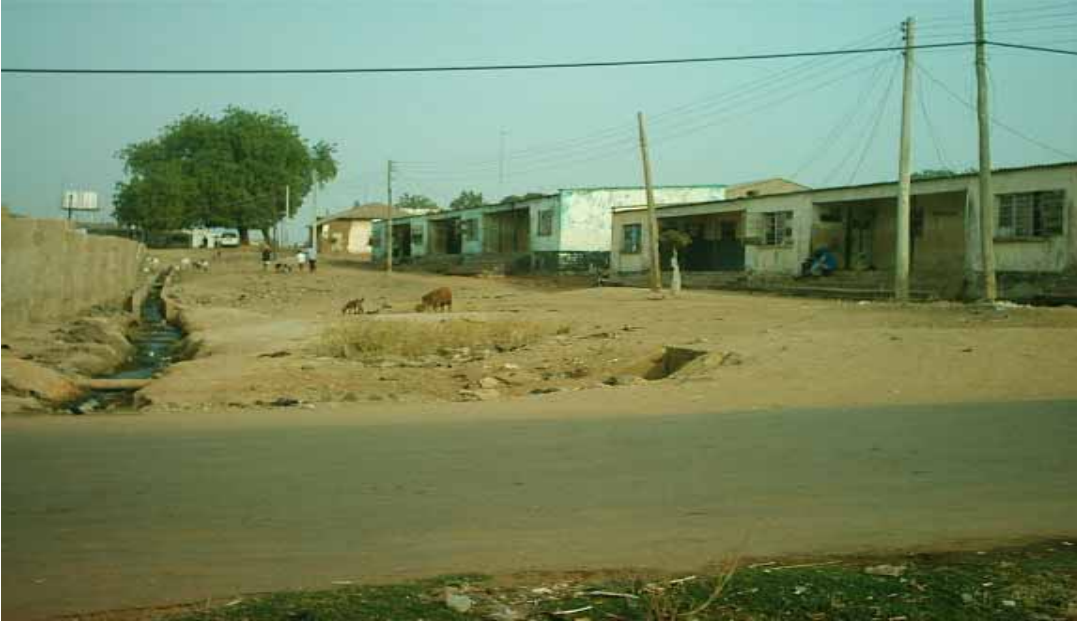
The walls of the low top houses in Yola are poorly constructed. In the sense that they could be unplastered, plastered and unpainted, or painted poorly using locally made paints

The walls are not straight and floors are not level as no plum was used during construction, rather the builders depend on their eyes and hands. The result is that most houses are misshapen and asymmetrical. The mixing ratio for the blocks and plasters contains too much sand in a bit to reduce cost cement and the result is that most houses start falling apart within months of construction. The heights of the walls are

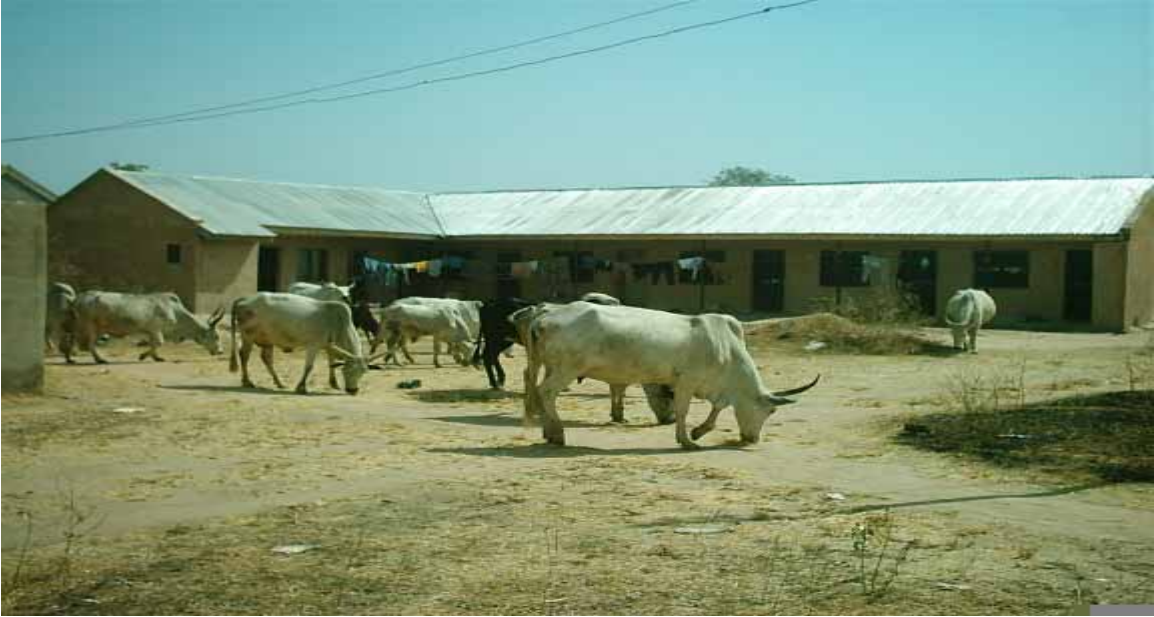
The doors used in these types of houses are of soft wood , mild steel, zinc with wood , untreated wood doors .These are crudely cut ,shaped and fixed and being of a height of less than 2100mm making people squat before entering into these buildings

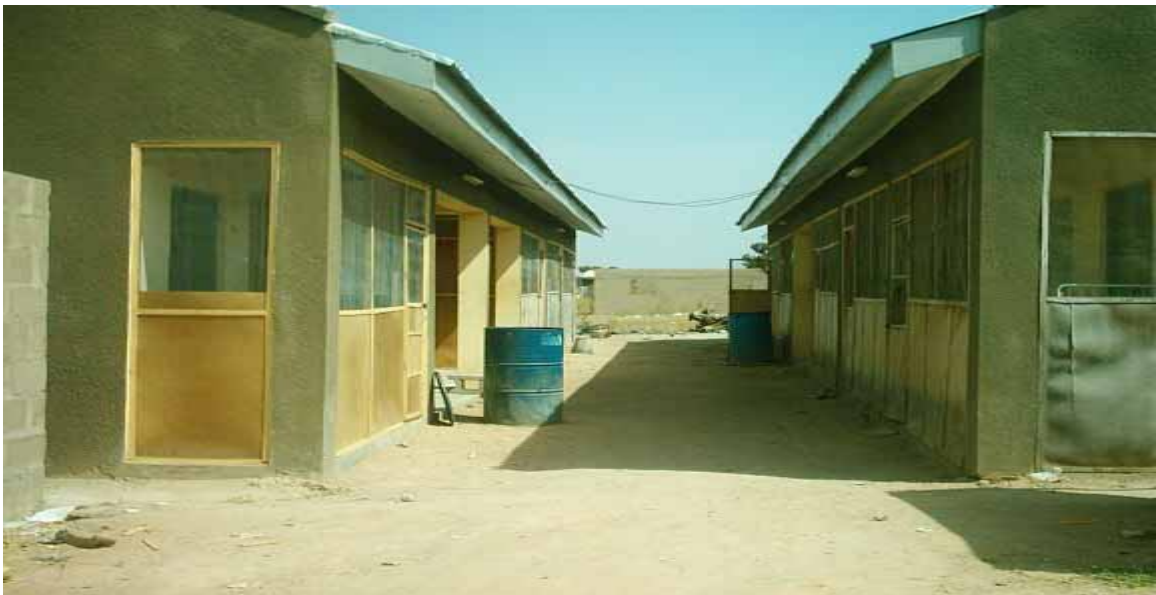
In the low trop architecture of Yola, there is poor or no ornaments in the buildings. This is because the people of Yola are not interested in the use of ornaments or have insufficient resources for extra beautification of their buildings.

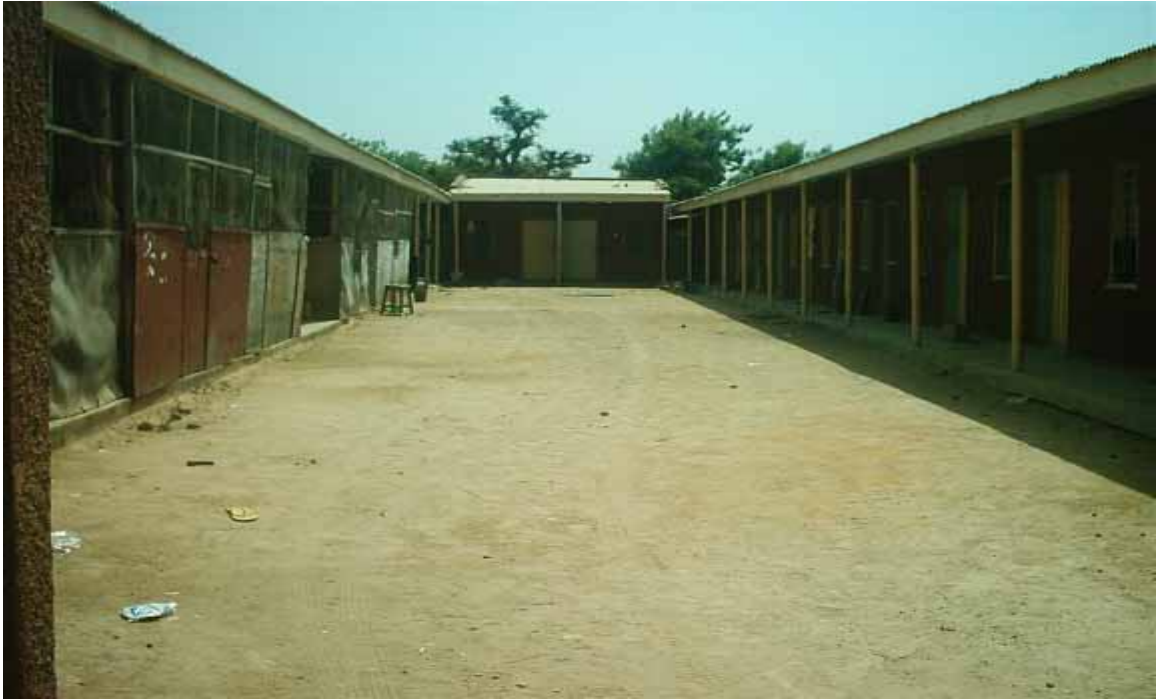
In the students' village in Sangere and Sabon-Gari, classic examples of poor workmanship which is to be expected from cheap local labour can be seen. Basically all the houses regardless of material used in building them have the traditional architectural pattern of the villagers since most landlords have no approved design or plan, but leave that to the ideas of the local builders. Such builders experience is limited to the type of houses they grew-up in, so they end up using modern materials like zinc, cement and concrete to build structures that are not different from mud houses.

These buildings are characterised by lean-to roofs and no opening other than the doors and the single window in the front of the building beside the door. In the village such a design is to ensure security, but the poor ventilation and lighting results in serious health problem for the inhabitants.

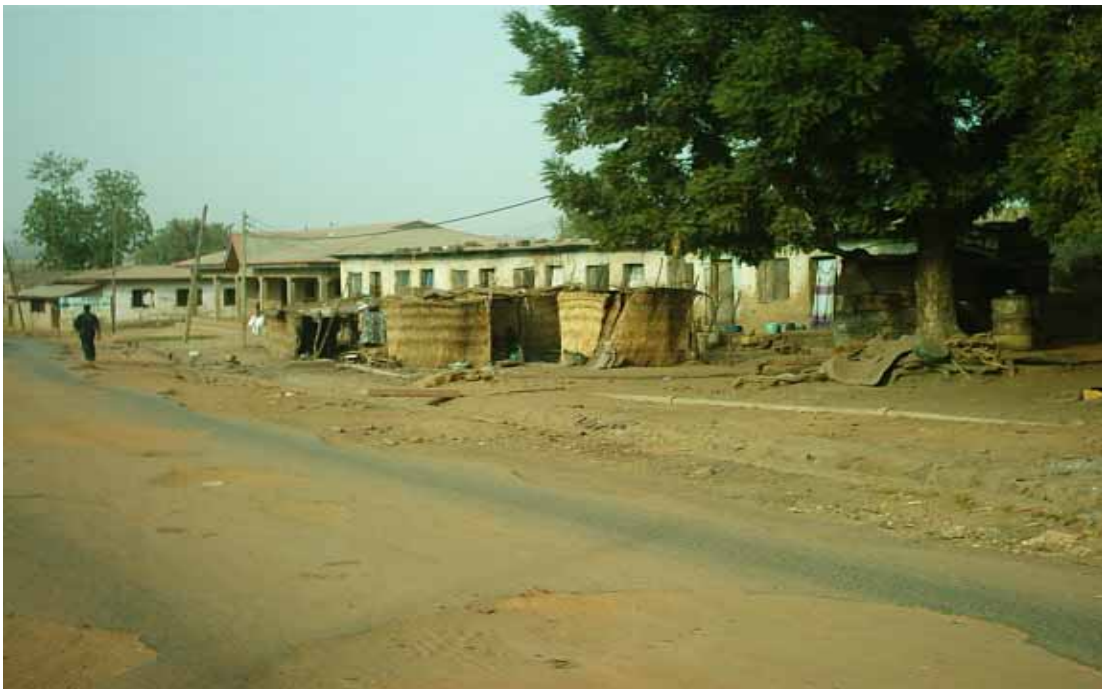
The buildings which have different plans from the traditional or village style are not much better. Walls are not straight and

floors are not levelled as no plumb was used during construction, rather the builders depend on proportion with their eyes.

Since the designers and builders of such houses have security as their primary concern no thought is given to comfort. Doors and windows are made of mild steel or zinc, which retain heat during the dry and rainy seasons rising the overall temperature inside the room to unbearable level.

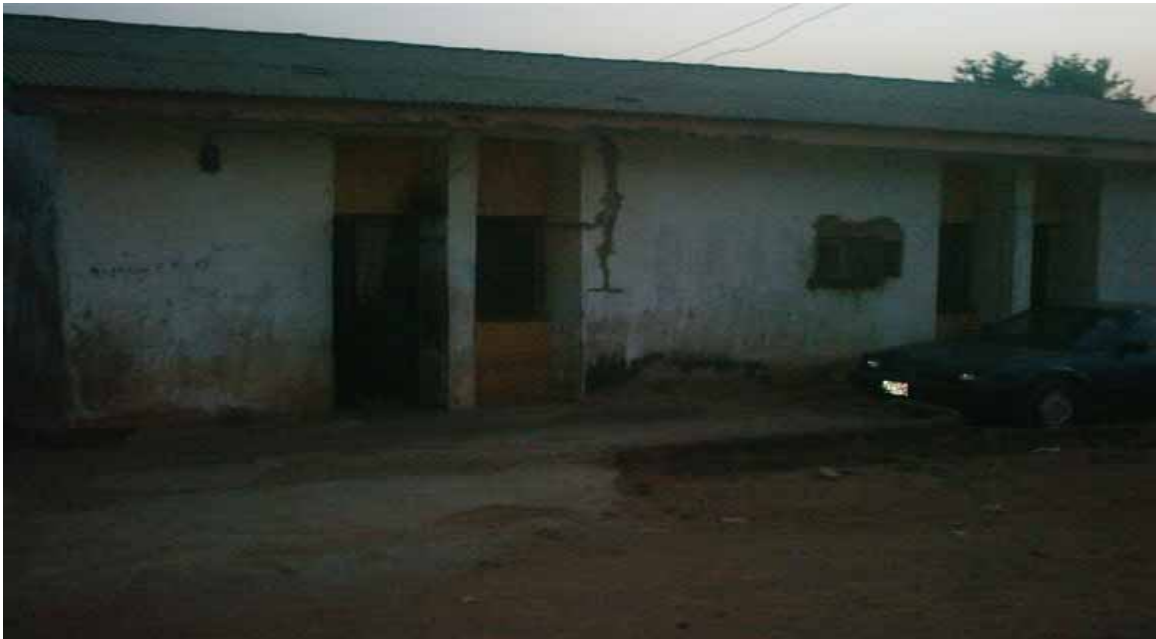
The direction of wind and path of sun are not considered in the orientation of the buildings so the inhabitants are at the mercy of the elements. Obviously, the low level of education or enlightenment of the builders has made them to construct vaults and not houses and since students are desperate for accommodation and the landlords will at no time whatsoever live in these structures, the situation is allowed to continue.
